# Scanning Acoustic Microscopy

Application area: non-destructive testing  
of electronic assemblies

Institute for Materials Research  
University of Hasselt  
Associated Lab IMEC

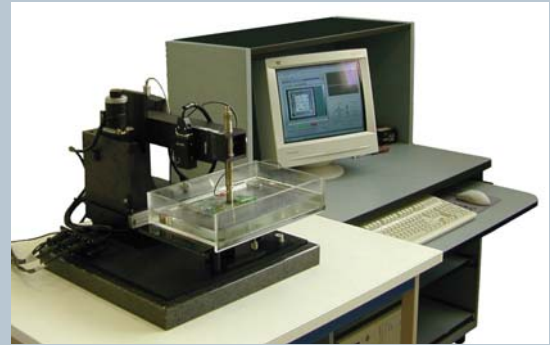
Scanning Acoustic Microscopy (SAM) is a non-destructive technique that uses a focused ultrasonic acoustic beam to scan the device under test. Ultrasound waves are transmitted through the device and the reflections from the different interfaces within the material are monitored. From the reflected pulses an image of the inside of the device is constructed.
